Guardian

The Dangers of Broken Neutrals and Stray Voltages

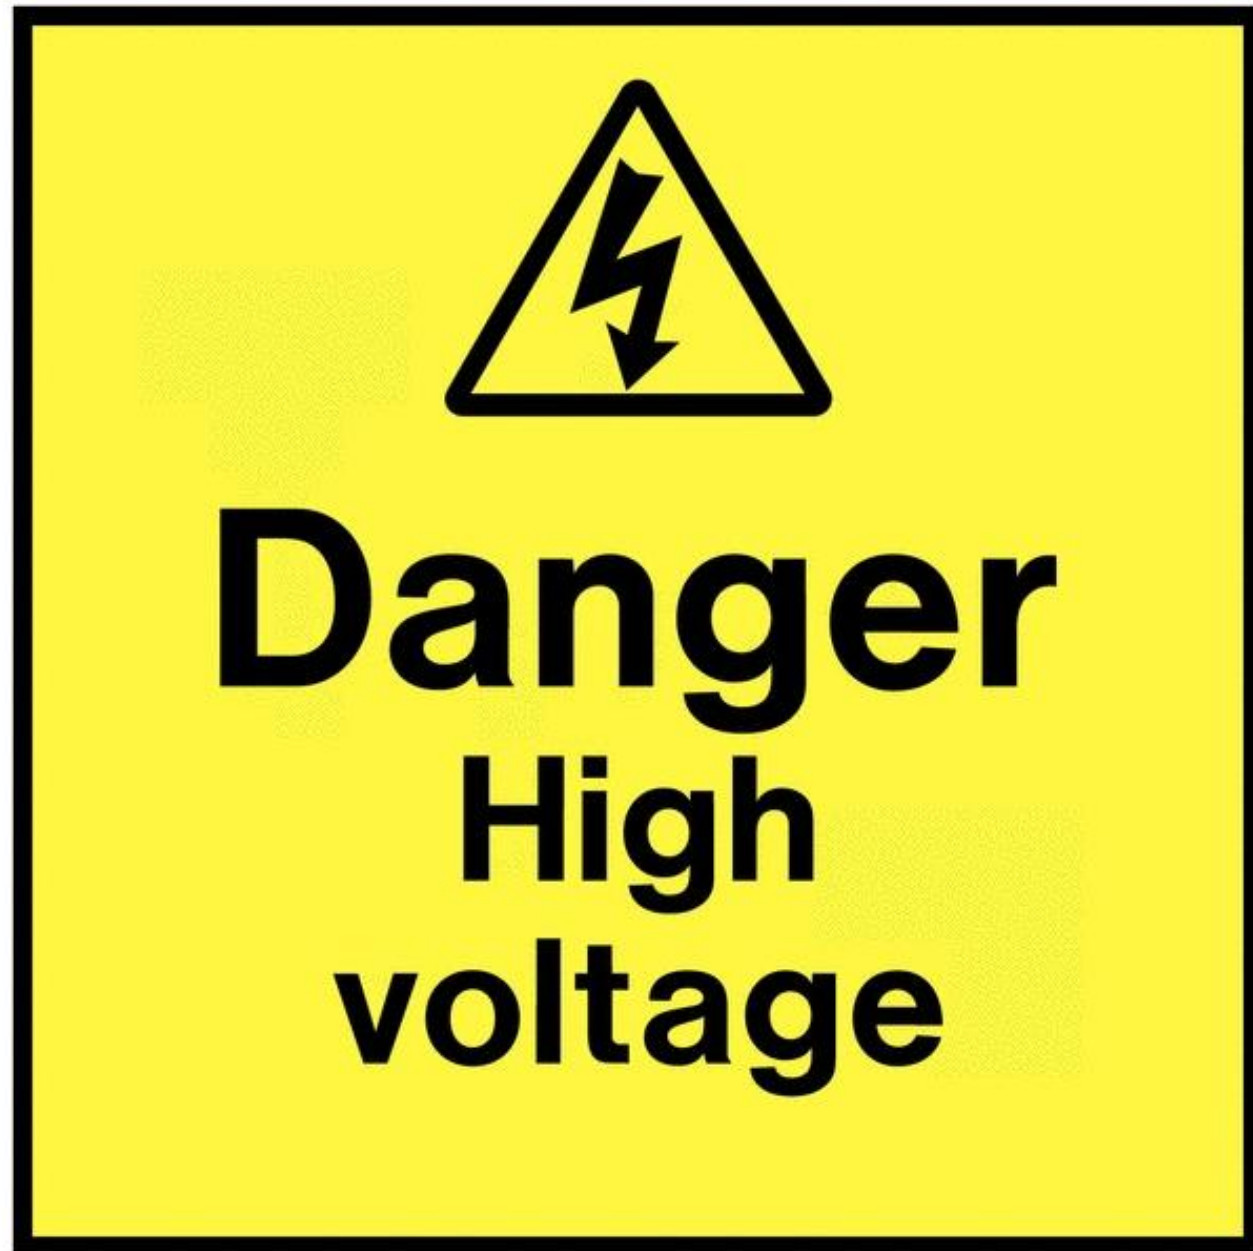
HIGH AND LOW LINE TO NEUTRAL VOLTAGES

FLOOR 1:	240V
FLOOR 2:	240V
FLOOR 3:	240V
FLOOR 4:	240V
FLOOR 5:	400V
FLOOR 6:	240V
FLOOR 7:	240V
FLOOR 8:	240V
FLOOR 9:	240V

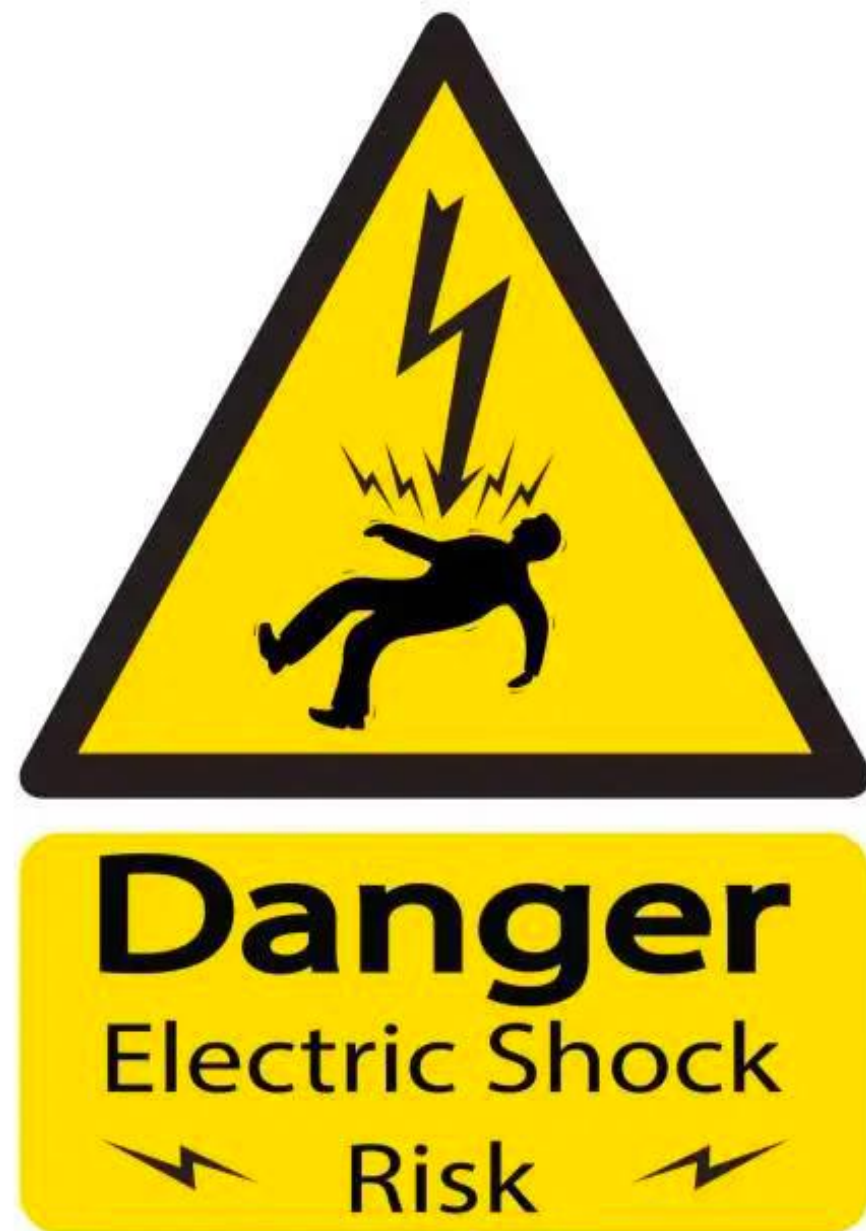
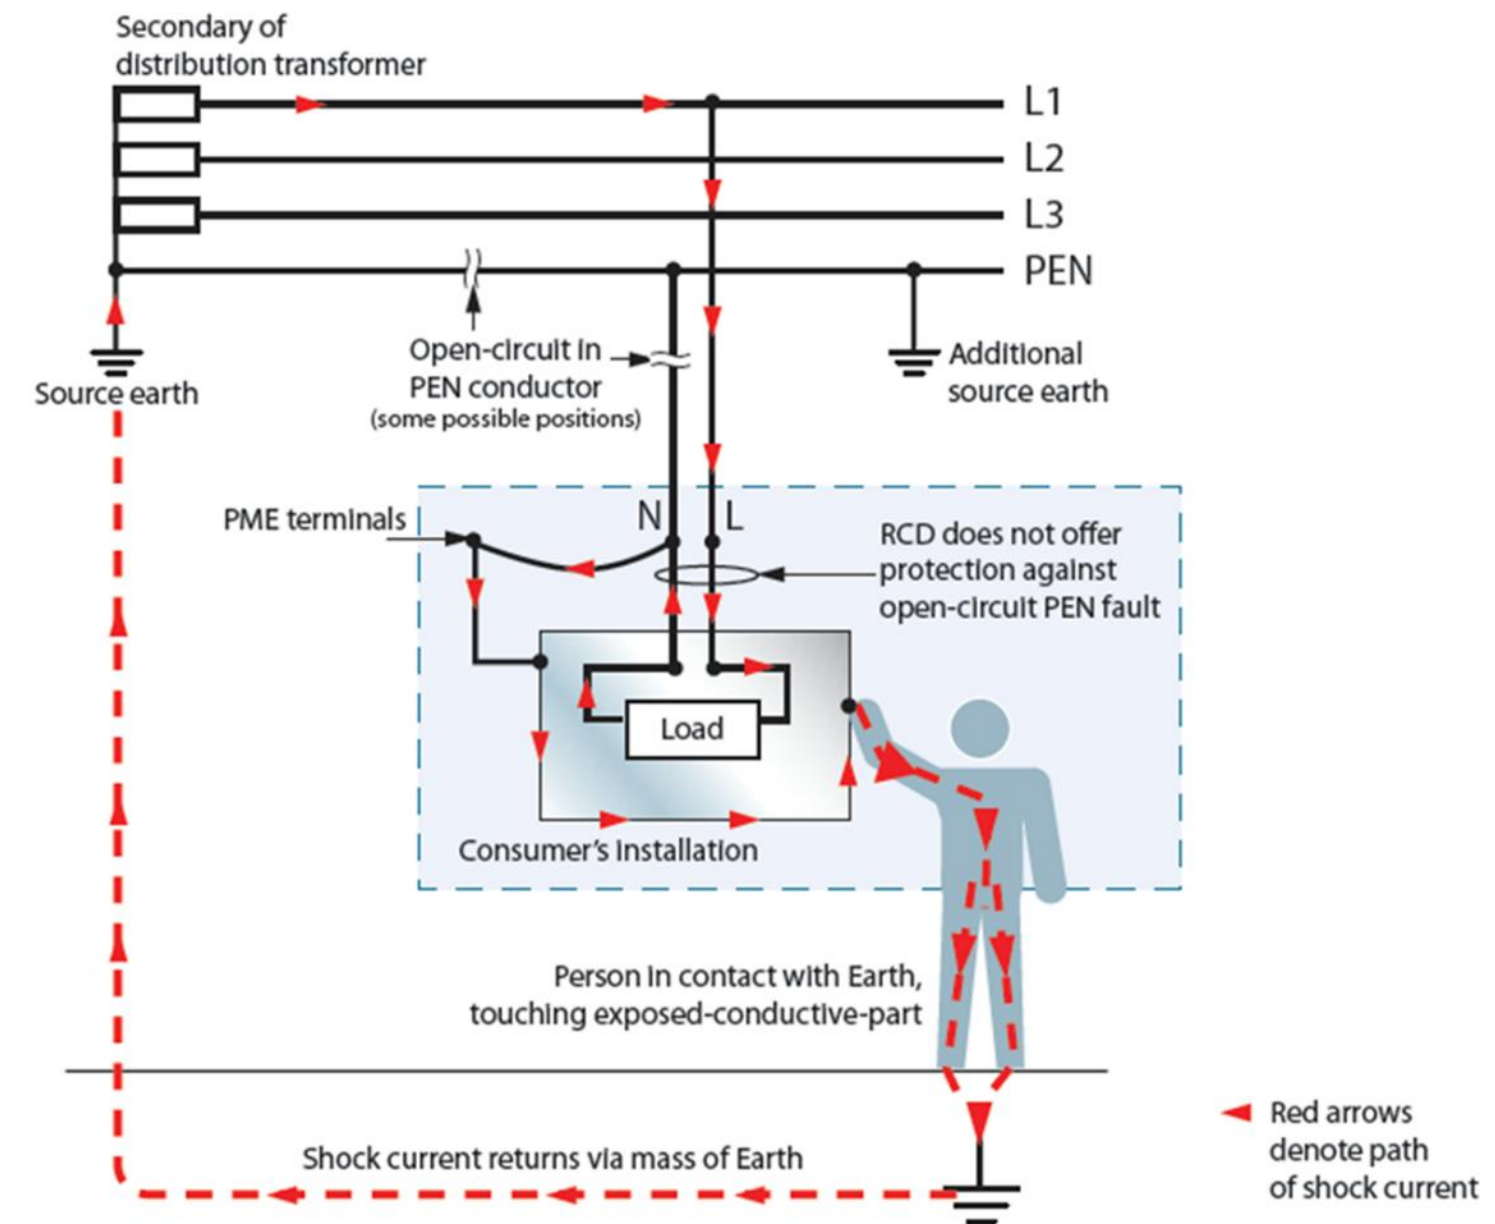
Fig 3 Electric shock risk due to open-circuit fault in the supply neutral PEN conductor

Broken Neutrals on the supplier's network or internally on sub supplies cause a real risk of electric shock.

Standard RCDs and MCBs **WILL NOT** detect the fault.

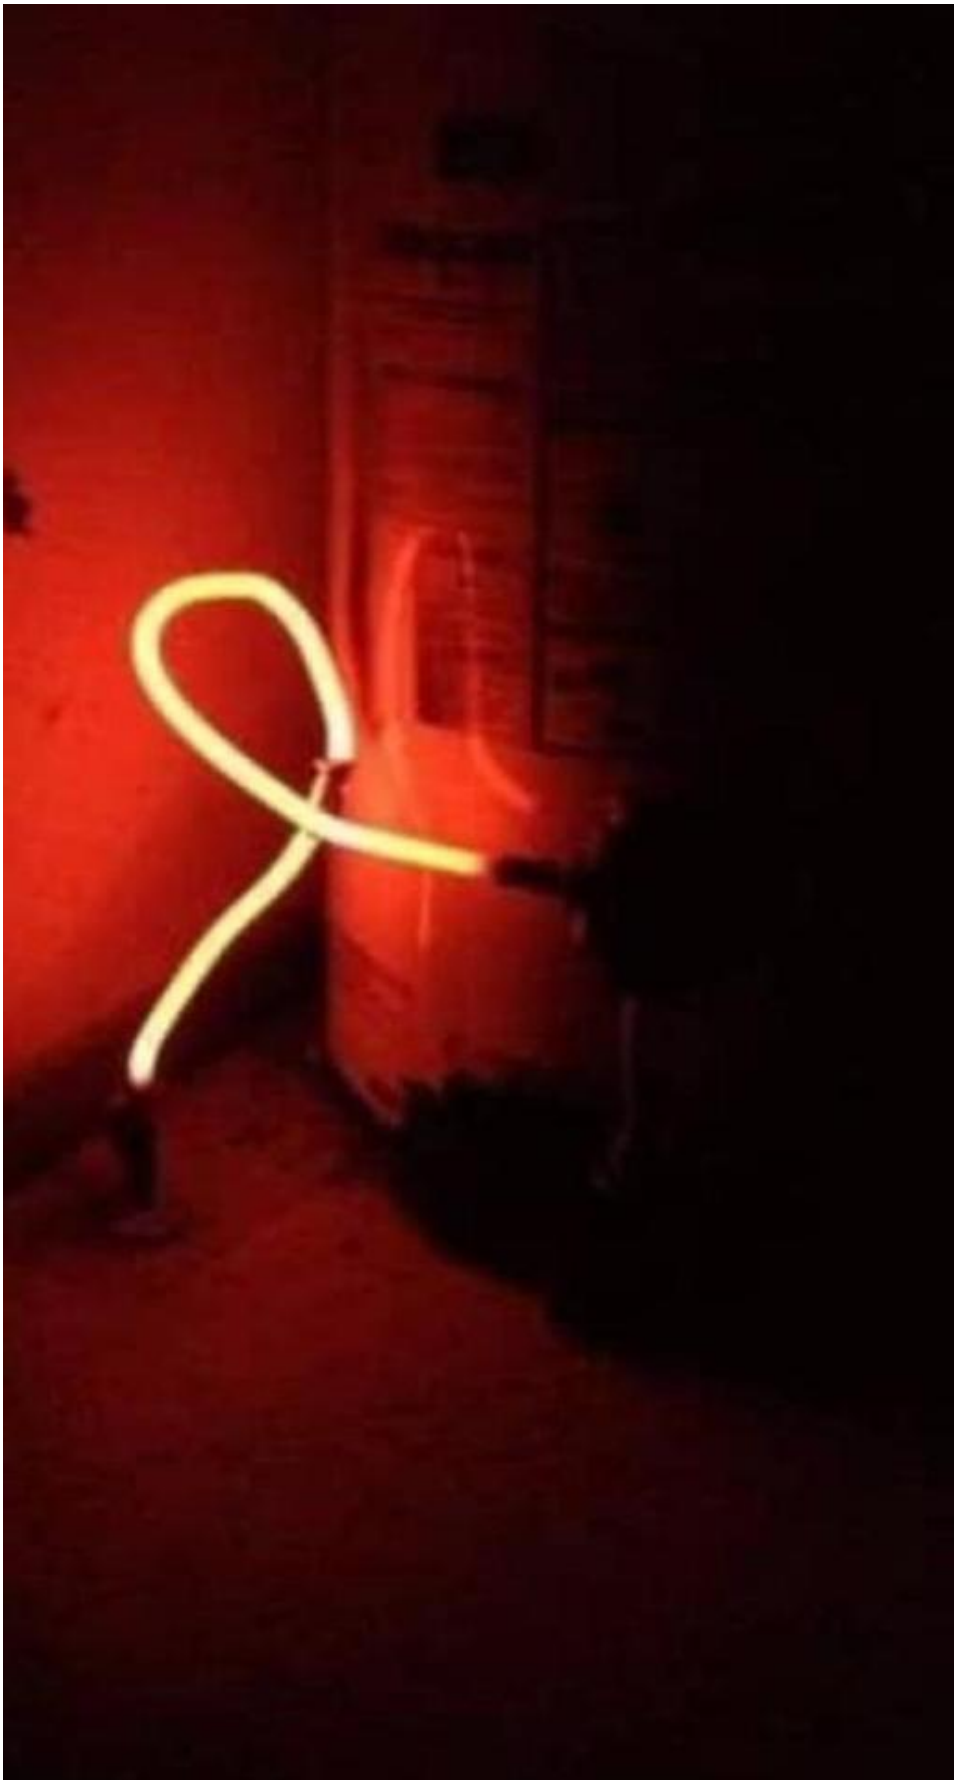
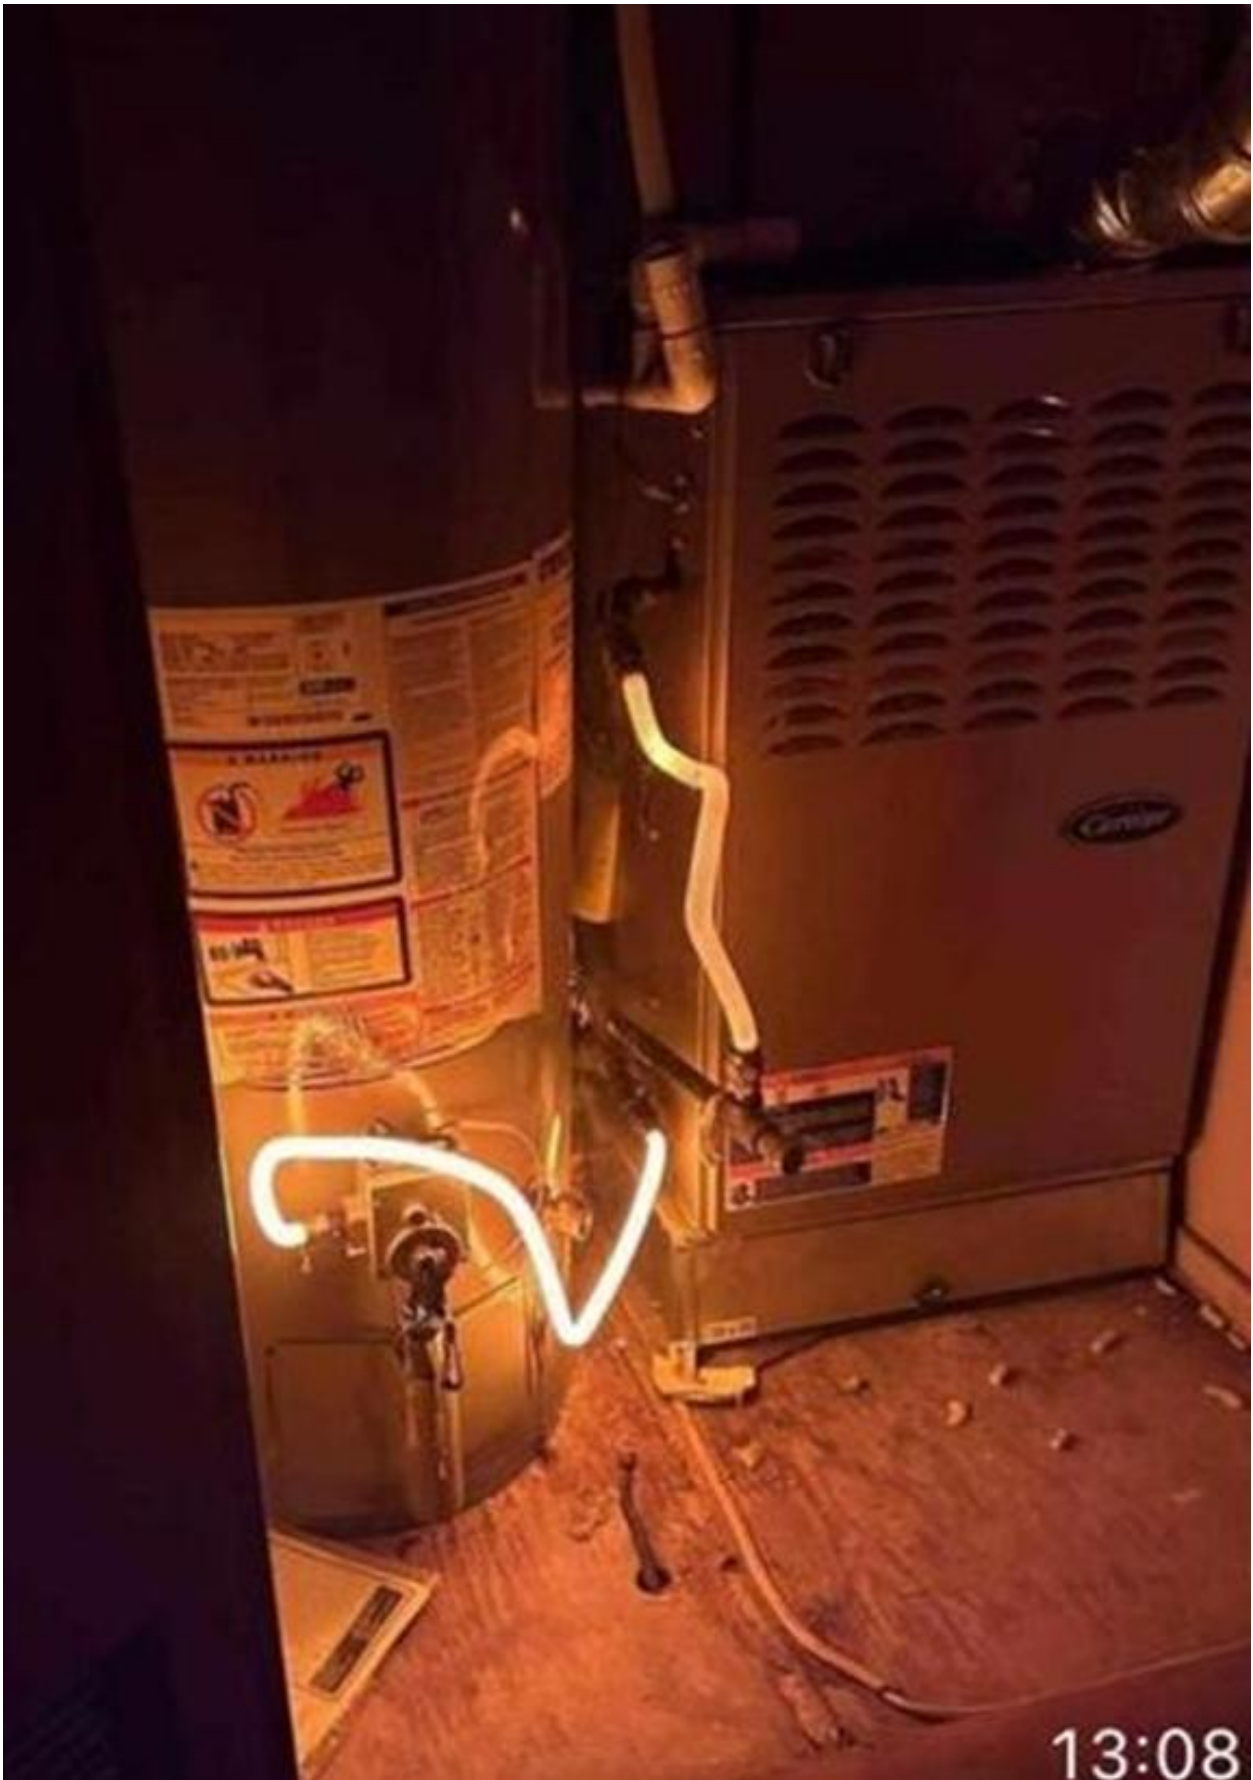
Real life examples of diverted neutral currents causing water and gas pipe work to glow causing a real potential fire risk.

Within older electrical installations, extraneous-conductive-parts often take the form of metallic water and gas installation pipework. In the case of an open PEN conductor, the path the current takes is effectively determined by the load and impedance on the network. Metallic gas and water pipe work offer low impedance paths for neutral current to flow, potentially resulting in a significant heat build-up that can lead to fires and gas explosions.

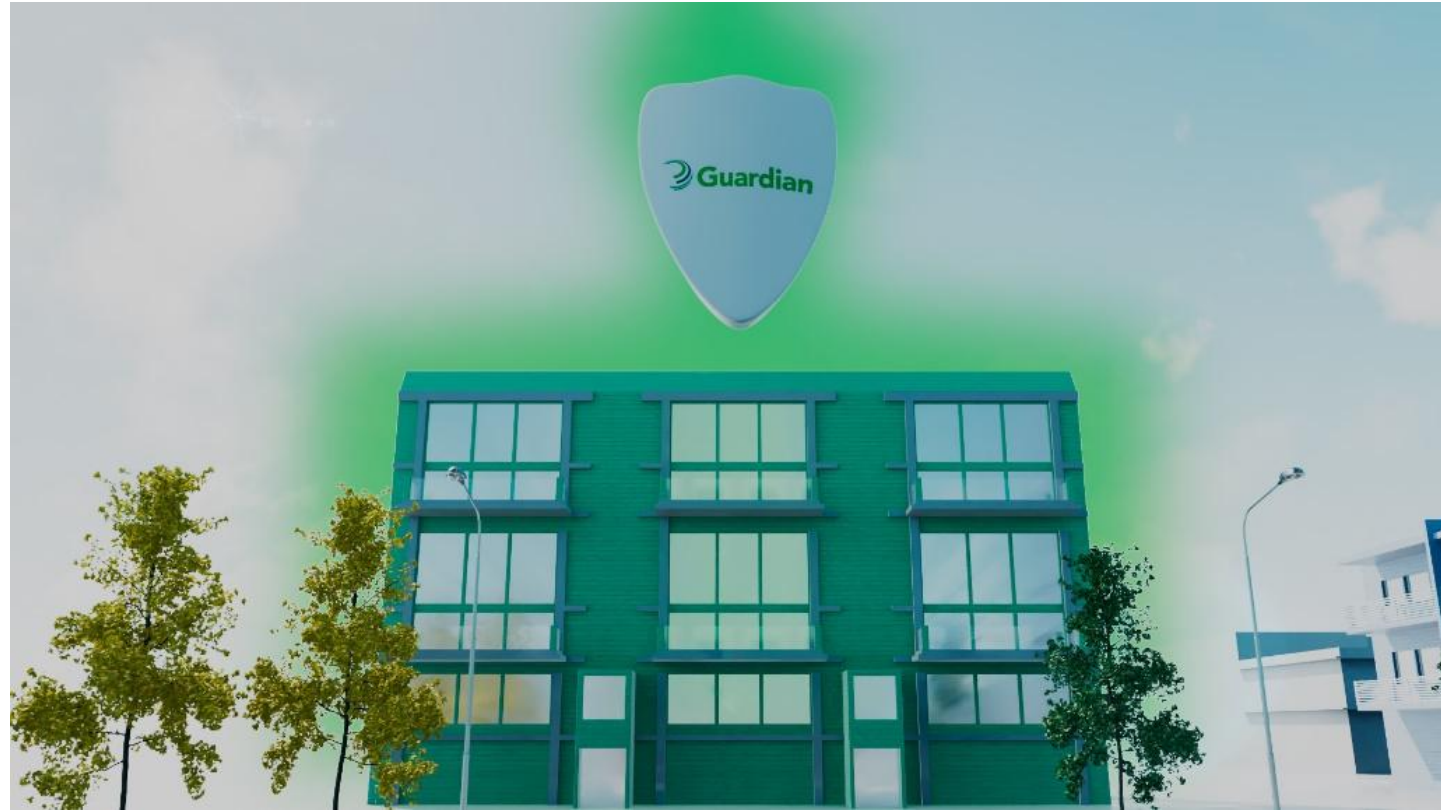
Installing Guardian to monitor the incoming mains supply and at each sub distribution board will help limit the risks caused by broken neutrals and help detect stray voltages on bonded services.

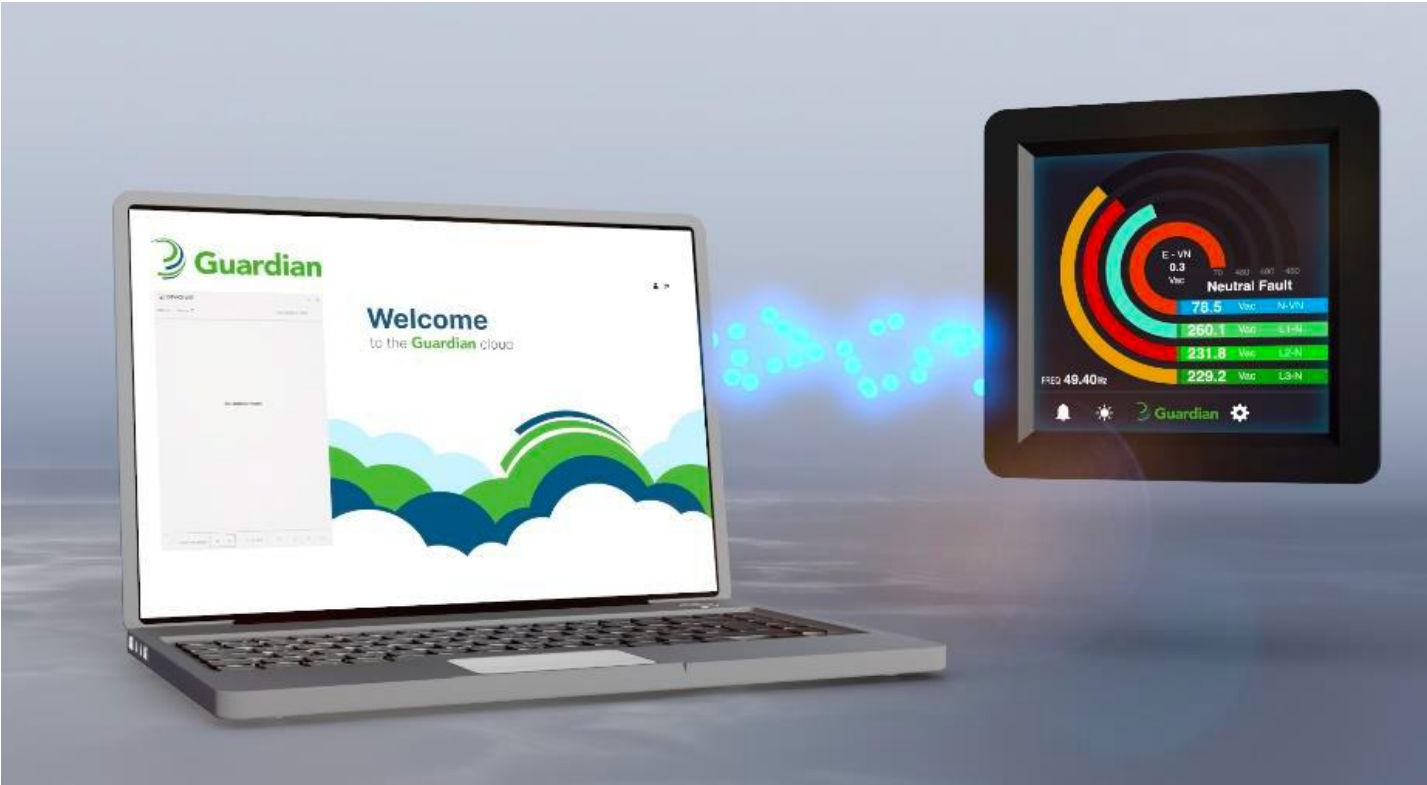
The Guardian can connect to the cloud-based portal or the customers own building management system where each device can be viewed remotely.

status	Enabled	Name ↑	Last Update Time
ALARM	YES	Guardian 1	24/04/2023,11:31:24
ON	YES	Guardian 2	24/04/2023,11:31:24
ON	YES	Guardian 3	24/04/2023,11:31:24

Guardian 1

L1-N VOLTAGE
230.85 volts

L2-N VOLTAGE
230.29 volts

L3-N VOLTAGE
231.44 volts

N-VN VOLTAGE
0.78 volts

E-VN VOLTAGE
0.64 v

FREQUENCY
68.01 Hz

ELECTRICAL NETWORK TYPE
3 Phase - 4 Wire
