Updating Priority Assumptions for Fire Department Responder Operations whenever Evacuees are also using the EXIT stairway

- **Building on six Decades of Professional Work:**
 - In Building Use Research and Consulting,
 - To Facilitate Counterflow in Exit Stair Use, by Evacuees and Fire Service Responders,
 - Focused on Ergonomics of Stairway Use in Emergency Situations including Fire.

Presented by Jake L. Pauls, BArch, CPE, HonDSc Presentation is based partly on images from videos shot in ordinary and state-of-the-art exit stairways of high-rise apartment buildings occupied for years by Jake Pauls in Toronto, ON and Silver Spring, MD. Here follow some ordinary and extraordinary examples.

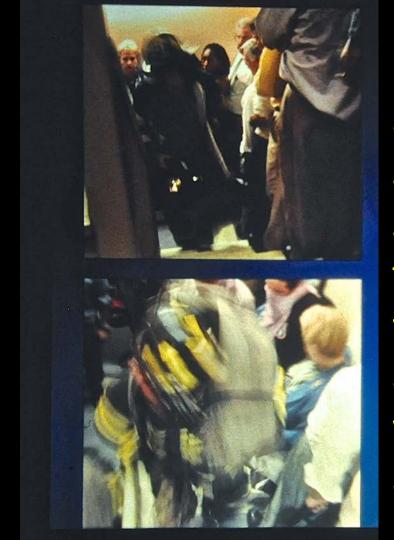
Outer side of stair bad for evacuees.

Especially on the WTC stairs, and generally on switchback stairs, descending evacuees should have priority use of the inner side of the stairs where proper handrails are available and overall descent would be significantly faster and significantly safer.

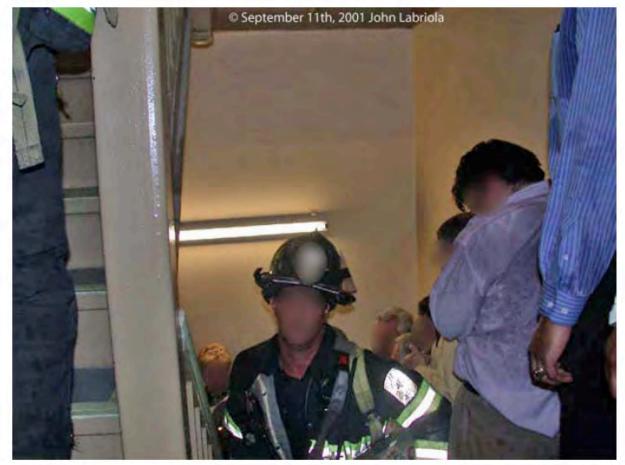
Figure 10–7. Firefighter and occupants using a 44 in. stairwell in WTC 1 on September 11, 2001.

John Labriola's photos of the WTC evacuation were taken in one of the two 44-inch, nominal width stairs in Tower 1. They clearly show the inadequacy of this stair width to facilitate counter flow by fire fighters.

Evacuees, on the right, have to stop and twist to the side avoid collision with the fire fighters.

WTC-911 Photo of Conterflow in WTC **Stairwell** by John Labriola

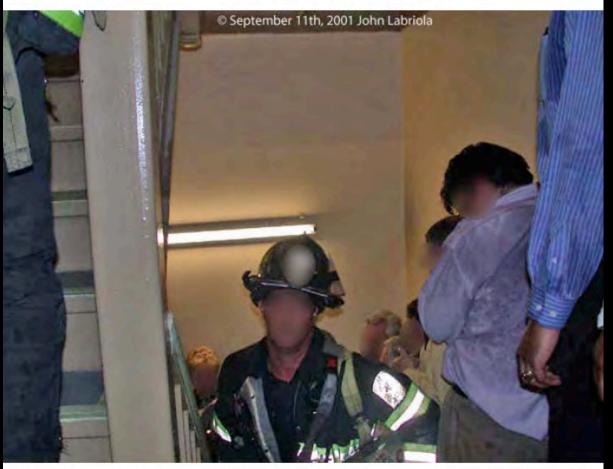
Figure 10–7. Firefighter and occupants using a 44 in. stairwell in WTC 1 on September 11, 2001.

Evacuees being forced to WTC stairs' outer side wasn't good practice—in hindsight.

Evacuee's path of travel and exposure increased to defective handrails

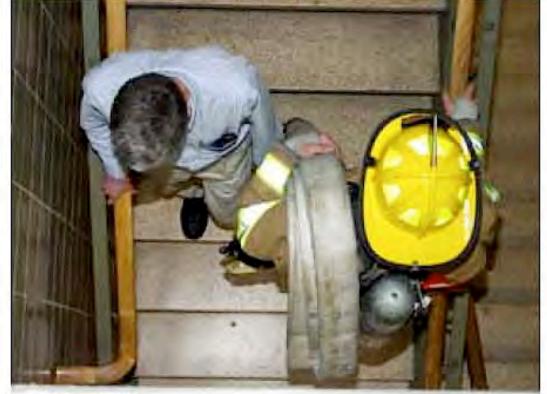
Figure 5-7. Top view of occupant and firefighter passing on stairs.

Source: NIST.

Evacuee's path of travel and exposure to defective handrails increased —even on

Notably, none of the illustrated examples show the firefighter on the outside lane of the stair.

Was this option even tested by NIST?

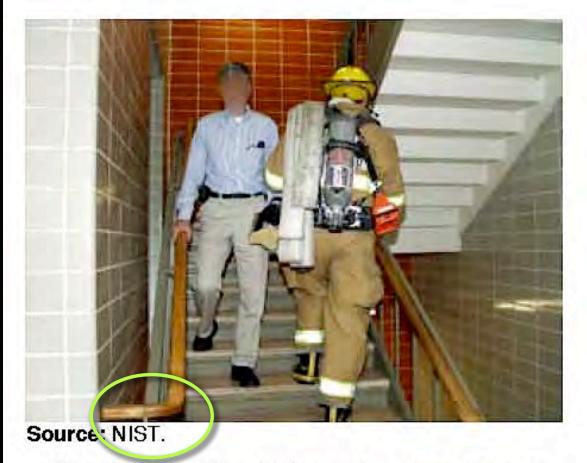
Figure 5–8. Front view of occupant and firefighter passing on stairs.

Evacuee's path of travel and exposure to defective handrails increased —even on this NIST stair!

Figures 5–7 through 5–10 show an occupant and a firefighter carrying a length of hose passing on a 1,118 mm (44 in) wide stairway. The Figures also show a firefighter and occupant passing at the landing. Note that the stair width does not provide adequate space for the individuals to pass without hitting each other. This occurs on the stairway as well as on the landing when the firefighter makes the turn to start climbing the next flight of stairs.

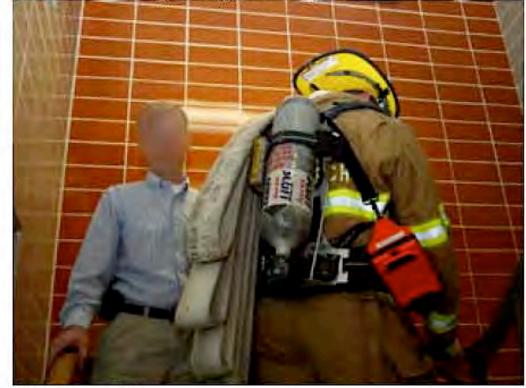
Figure 5–9. Front view of occupant and firefighter passing on landing.

Evacuee's path of travel and exposure to defective handrails increased

—even on this NIST stair!

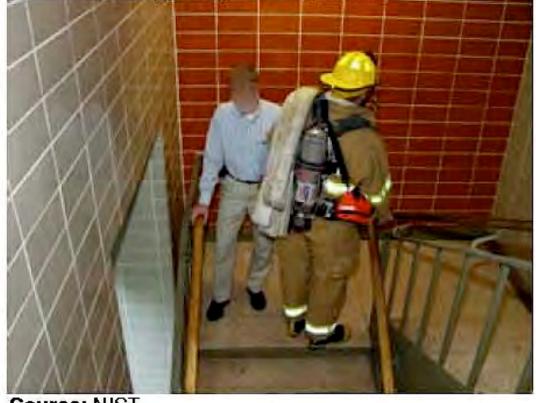
Figure 5-10. View from above of occupant and firefighter passing on landing.

Evacuee's path of travel and exposure to defective handrails increased

—even on this NIST stair! Figures 5–7 through 5–10 show an occupant and a firefighter carrying a length of hose passing on a 1,118 mm (44 in) wide stairway. The Figures also show a firefighter and occupant passing at the landing. Note that the stair width does not provide adequate space for the individuals to pass without hitting each other. This occurs on the stairway as well as on the landing when the firefighter makes the turn to start climbing the next flight of stairs.

Notably, none of the illustrated examples shows the firefighter on the outside lane of the stair.

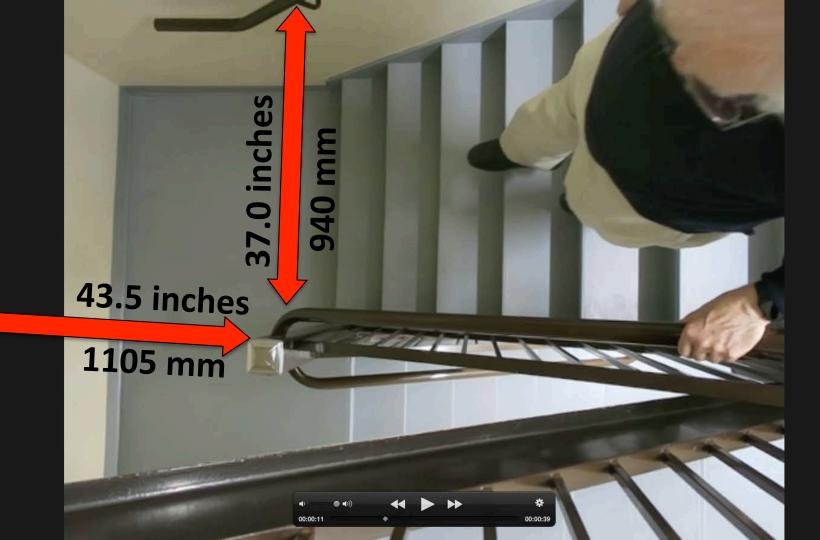
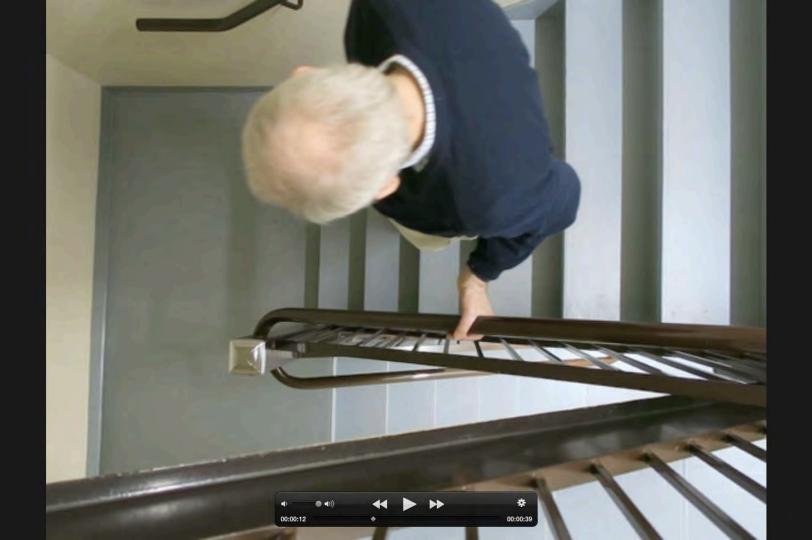
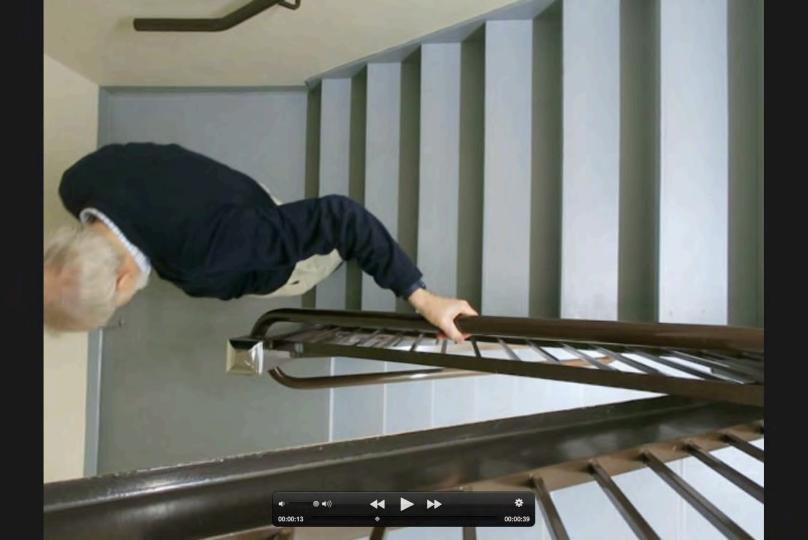
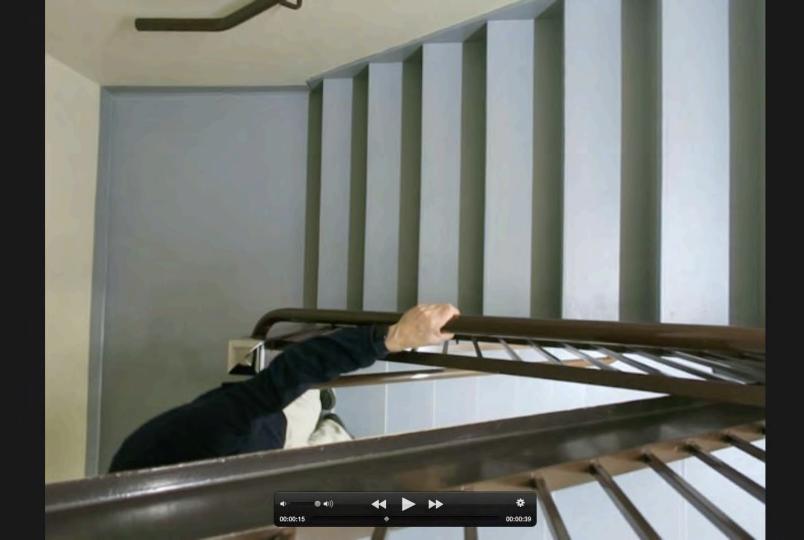
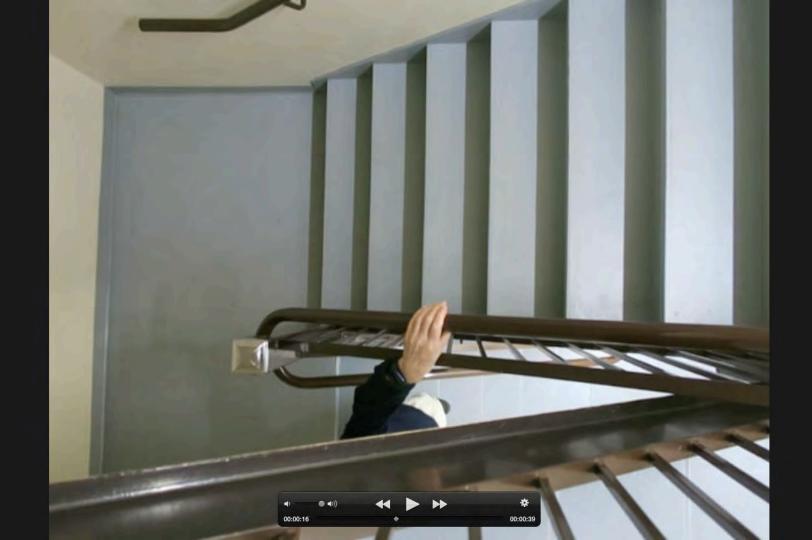
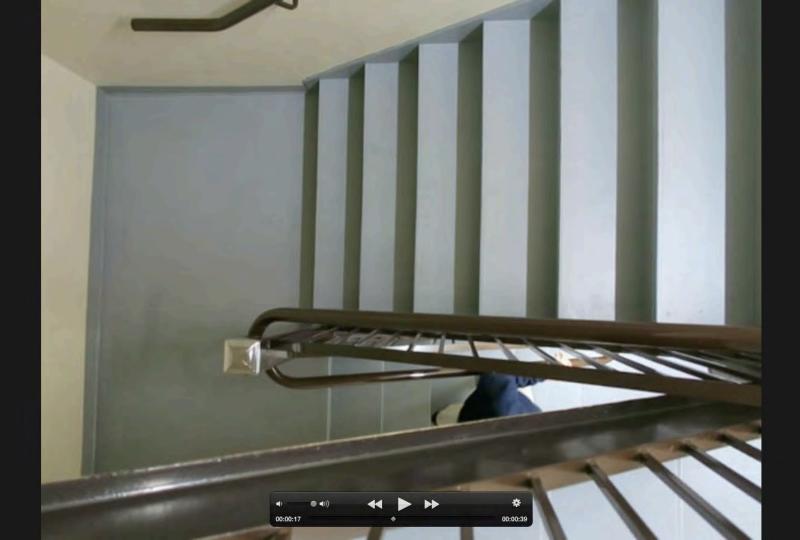
Handrail Use on Dogleg (Switchback) Stairway

Based on images from videos shot in Jake Pauls' apartment buildings, in 2024, in Toronto, ON and Silver Spring, MD, respectively at 22nd floor and 10th floor EXIT stairways.

Each sequence—descent and ascent—depicted lasted about 6 seconds.

Now, to be addressed with crowd-use studies, is to what extent such handrail usage patterns—which are supported by handrail erosion patterns—is, or is not, also found in crowd use of stairs.

The latter should be using the outer part of the stairway so they ascend with less interference to occupant descent flow.

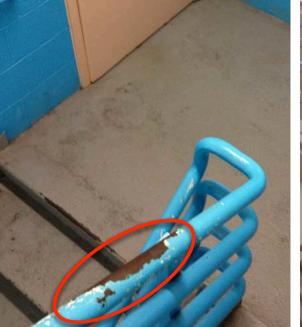
Handrail Use on Dogleg (Switchback) Stairways

Jake Pauls has collected handrail erosion records showing fairly consistent patterns of erosion from hands of stair users for a variety of public, dogleg stairs. Note that the hand grip rotates around the circular-section railing in this behavior, creating friction potent enough to erode and polish the railing coating.

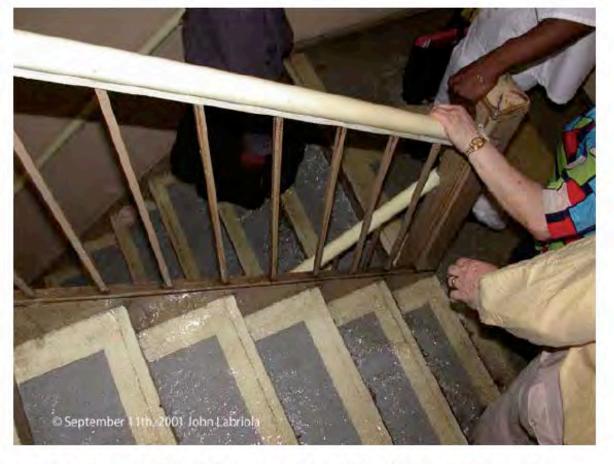
Figure 2–10. 44 in. stairwell in WTC 1 taken on September 11, 2001.

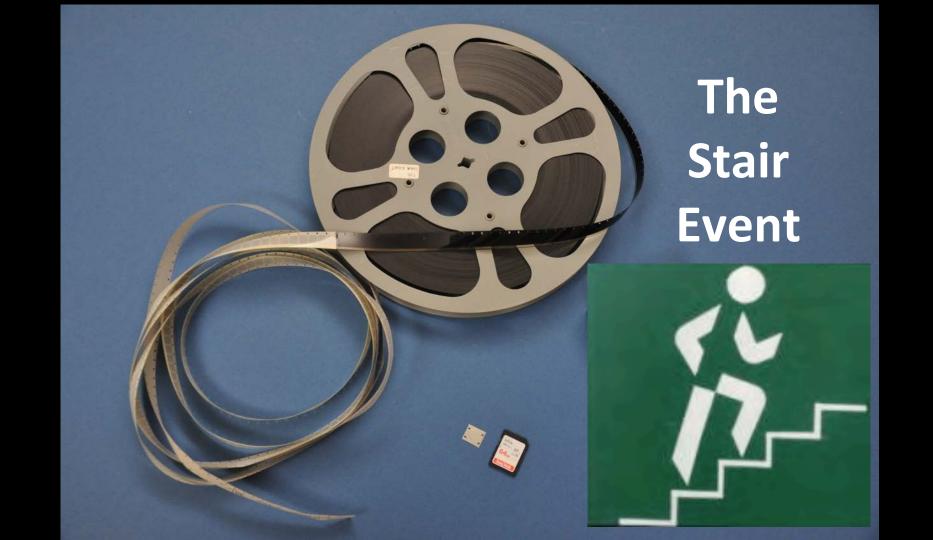
Movie Clip from "The Stair Event" (Click: 47 Subjects) Correct Flow Duration: 25 sec: *Mean Flow: 110 p/min

- *Original filming done at 18 fps
- but film production was at 24 fps
